# STATE OF FACILITIES

City of Toledo Fire and Rescue Department

March 2023

## Toledo Fire and Rescue Department

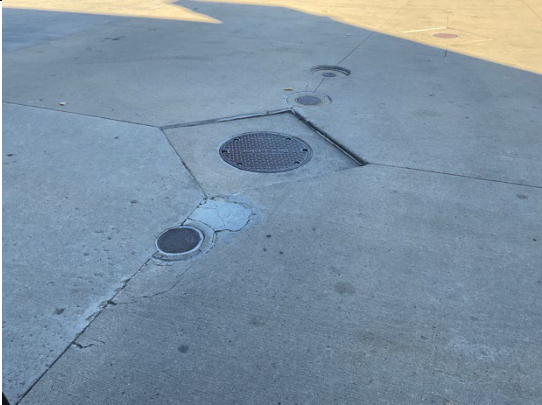
| Building | Description | Photo |
|---|---|---|
| Station 6 | Exterior Drainage | A photograph showing a concrete surface with a circular drain cover and a smaller, partially covered drain. A yellow curb is visible in the upper right corner. |

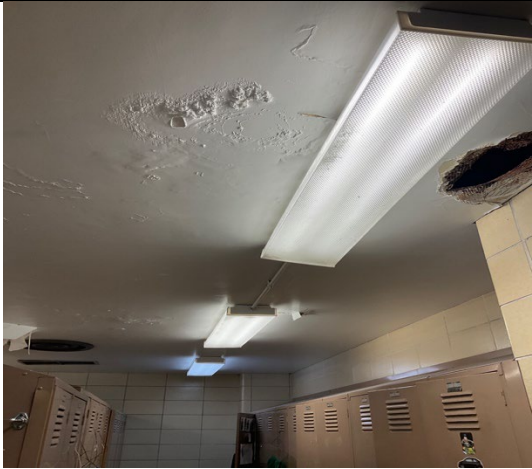
| Building | Description | Photo |
|---|---|---|
| Station 7 | Interior Paint | A photograph of an interior space, likely a locker room, showing significant peeling and cracking of the ceiling paint. A fluorescent light fixture is visible on the right. |

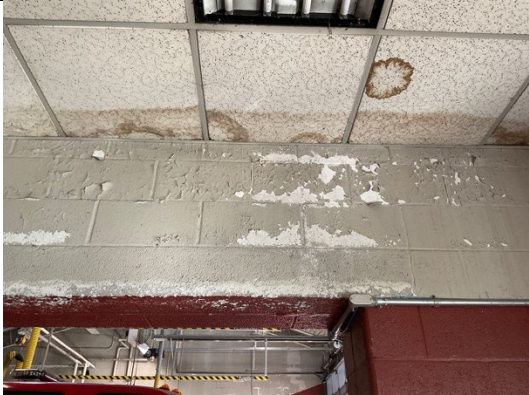
| Building | Description | Photo |
|---|---|---|
| Station 13 | Interior Paint | A photograph of an interior wall showing extensive peeling and cracking of the paint. A red fire door is visible on the right side of the frame. |

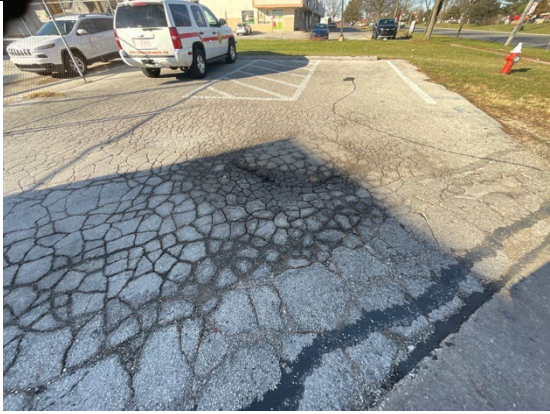
| Station 16 | Parking Lot - Asphalt | A photograph showing a close-up of a parking lot surface made of asphalt. The asphalt is heavily cracked and weathered, with a large, irregular crack running across the foreground. In the background, a white van and other vehicles are parked on a similar surface. |
