Rebuilding the Ottawa-Jermain Park Amphitheater - Phase Two

Rebuilding the Ottawa Park Amphitheater Phase Two

Ottawa Park Amphitheater

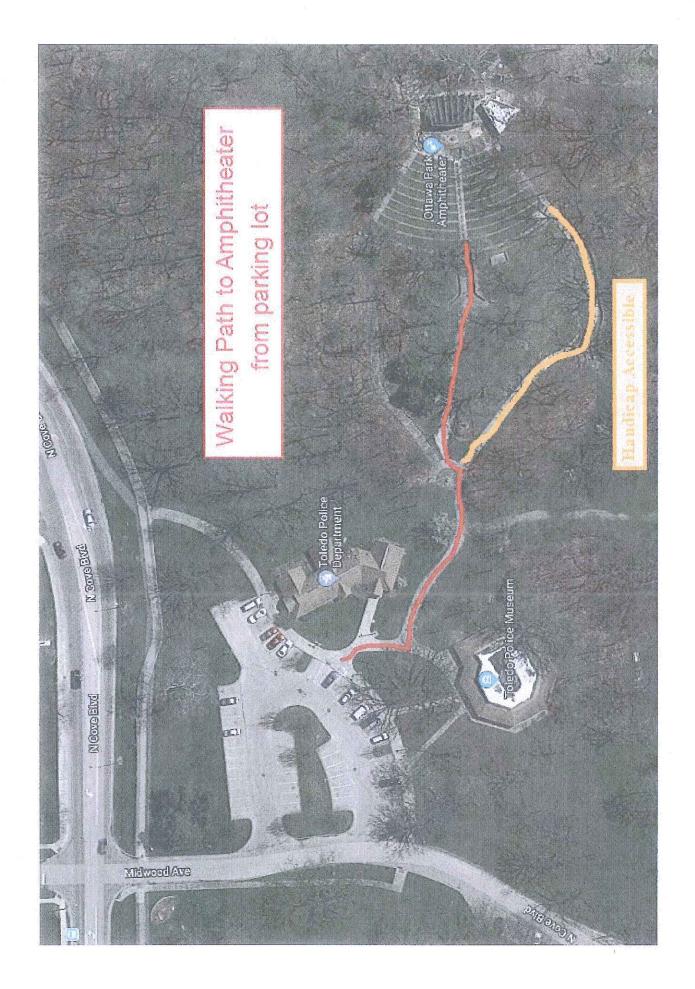
- o Handicap accessibility. Only a portion of the walk is currently accessible, as shown in the attached photo.
 - Safety & Comfort. Many of the steps are worn/damaged, and unsafe to use. Support railings were missing on various steps. There was no lighting available for the public, or the performers. There are no permanent restrooms—the ones in the Police substation and Police Museum are not open to the public. Only Port-a-potties were available for major events. There are no benches in the vicinity. No concessions are available. No flowers or plantings.

- Signage and entrances. The press has often called this amphitheater a "hidden jewel". It certainly is hidden! Even standing in the parking lot, one has no idea that there is an amphitheater in the vicinity. The attached photo shows the problem.

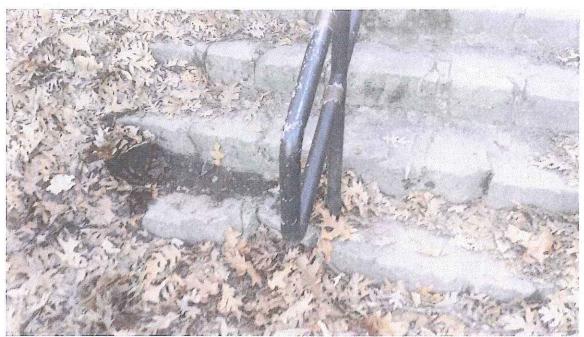
As seen in figure 1 below the stones which line the staircase and act as an earth retainer have been badly damaged due to weathering and lack of maintenance. Many of the stones are either completely missing or are fragmented and scattered about the area. Due to the loss of these stones the slab staircase has also been damaged and fractured. In addition the current retaining wall (Figure 2) has lost a number of its stones throughout the wall and the end of the wall has begun leaning, resulting in a sharp edge which may pose a danger to individuals unaware of it. The central staircase (Figure 3) which contains a railing has been damage to a number of the steps. These steps are missing large pieces of stone (Figure 4) which pose a danger to people walking down the steps. This damage may have been caused by a combination of both weathering and mountain bikers repeatedly misusing these steps.

Figure 2: Current retaining wall in disrepair

Essential repairs need to be addressed right away before any construction or addition can be made to the amphitheater site. As stated previously, the state of deterioration of some earth retaining walls and steps are critical, and may even impose risk to the public frequenting the amphitheater. All the loose stones will be replaced with mortar, edges of the steps will be straightened, throughout the amphitheater, and asymmetrical aspects due to deterioration will be brought to their original symmetric shape, to keep the identity of the amphitheater. Also, the bottom of the stairs leading to the amphitheater, are very steep, and an additional step will be added to each set of stairs to make it more accessible.

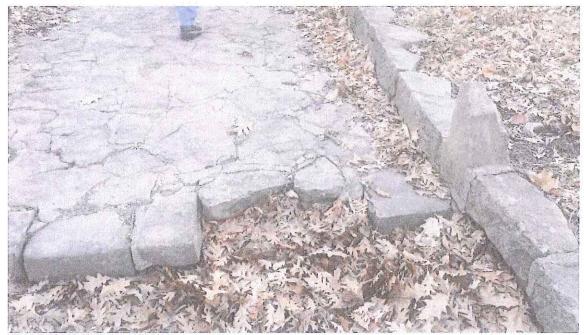
Figure 3: Deteriorating center stairs

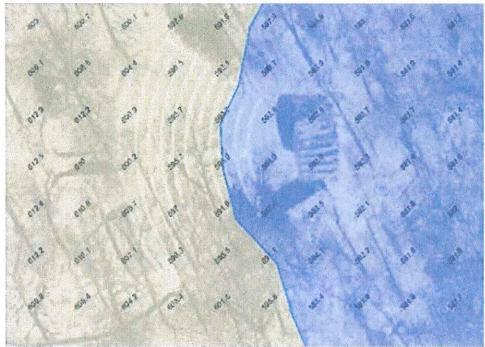
As of now the storage facility adjacent to the amphitheater stage is not being used due to its location within the flood zone as seen in Figure 5. The group has utilized the Flood Maps provided by the FEMA website and personally performed a topographic survey to delineate and confirm the location of the flood zone with more accuracy.

The fact is, however, that frequent flooding renders this location useless for storage of materials such as the murals on the amphitheater stage. This leaves the possibility for vandalism or weather damage to these murals. During heavy storms water levels at this location can exceed over two feet in depth.

Figure 5: Current flood zone location

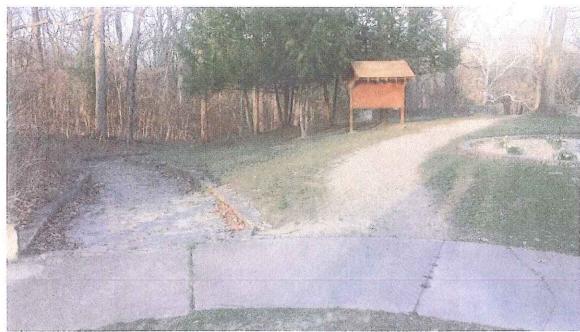
Much of the sidewalks leading to the amphitheater are unpaved. This generally reduces the accessibility to the amphitheater and in some cases may pose a danger. Unpaved paths may become saturated with water and slick after severe weather and may limit individuals with disabilities from using them. A paved sidewalk will lead to a safer more pleasant walk to the venue and encourage people who would be dissuaded due to a gravel path. We can see from Figure 6 & 7 how this path takes away from the venue and how providing a paved walkway will improve the areas accessibility.

Figure 6: Gravel path leading to amphitheater

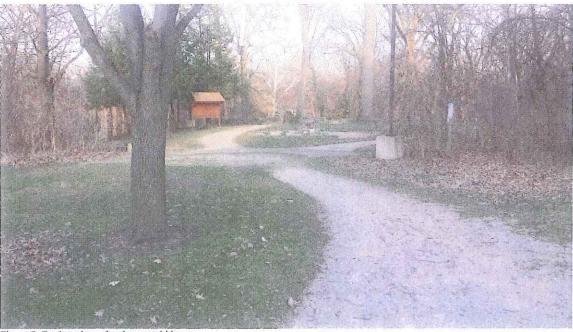
Figure 7: Further view of path to amphitheater

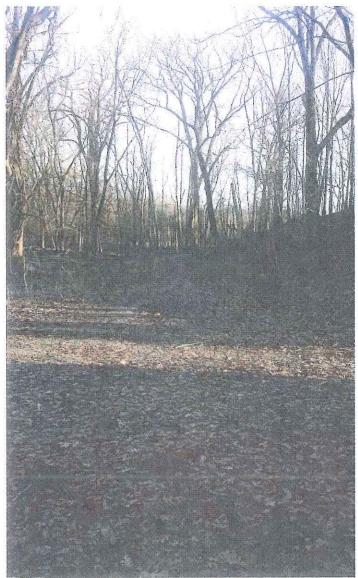
Figure 8: Unpaved back entrance road to the amphitheater

The rear access road to the amphitheater is unpaved (Figure 8) and in many cases does not provide sufficient access to a variety of vehicles that could use it. This road could allow access to the amphitheater for handicap accessibility vehicles and larger trucks carrying equipment for venues at the amphitheater. Having an unpaved road may also pose a danger to vehicles if there has been a recent storm resulting in a vehicle getting stuck. Paving this road will increase visibility and accessibility to the amphitheater.

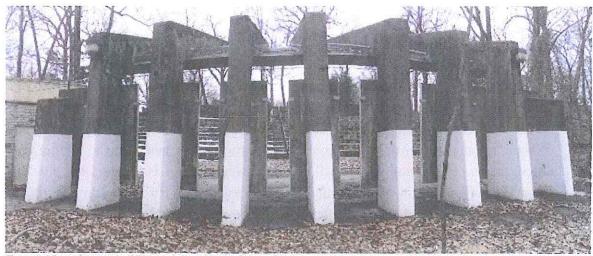
Other than being unable to serve its purpose, due to seasonal floods, the existing storage facility is located adjacent to the amphitheater stage, as if misplaced (left side of Figure 9), interfering with the balance and acoustics of the stage. The decision to remove it was obvious, and should be done right away, since currently there is no use for that facility. Additionally, this facility is built with stones, which match the original historical stones that make up the rest of the amphitheater; upon demolition, the stones removed from this building will be using for the miscellaneous stone repairs previously mentioned. This will be cost effective, and will make it possible to keep the uniformity of the layout by using materials that are already on the site.

Figure 9: View of storage building (on left) and back of stage pillars

The pillars of the stage are only painted halfway currently, and it is aesthetically unpleasant as can be seen in Figure 9 above. Also, the pain on the ceiling of the stage is deteriorated and old, therefore the team decided that this should be addressed right away to attract the public to a better looking amphitheater.
