## TECHNOLOGY BULLETIN

JUNE 1998 FORESTRY REPORT R8-FR 63  
USDA FOREST SERVICE / SOUTHERN REGION  
1720 PEACHTREE RD., NW ATLANTA, GA 30367  
SOUTHERN RESEARCH STATION  
320 GREEN STREET, ATHENS, GA 30602

### HOW TO PROTECT TREE ROOTS WHILE REPLACING SIDEWALKS AND CURBS

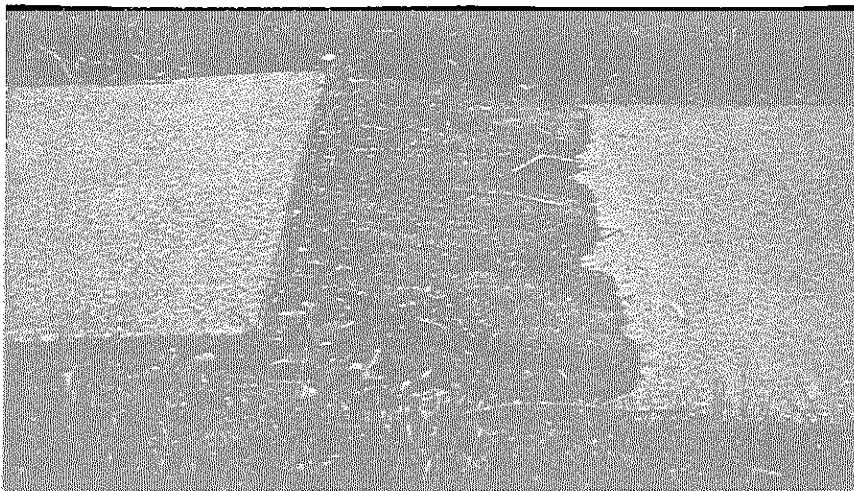
This repair is usually considered temporary, but it is one of the simplest ways of repairing a displaced slab, or "stub-toe." In this repair an asphalt wedge is applied between the upper and lower slab of the walk (fig. 1). Such repairs rarely correct the prob-

Figure 1. Asphalt wedge

lem, but they do reduce the danger to pedestrian traffic.

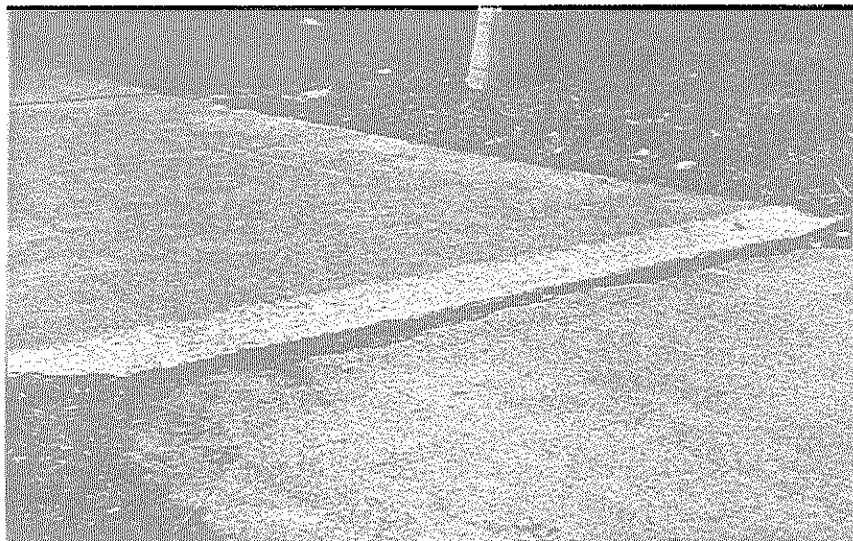
Another simple, low-cost alternative for repairing a displaced sidewalk is the use of a mechanical grinder to wear down the raised edges of the slab (fig. 2). Grinding is generally limited to concrete slabs with less than 1 inch of displacement. It may be possible to grind away edges with 2-inch displacement; however, if 50 percent of the slab thickness is removed, the structural integrity of the concrete may be lost.

Figure 2. Mechanical grinding

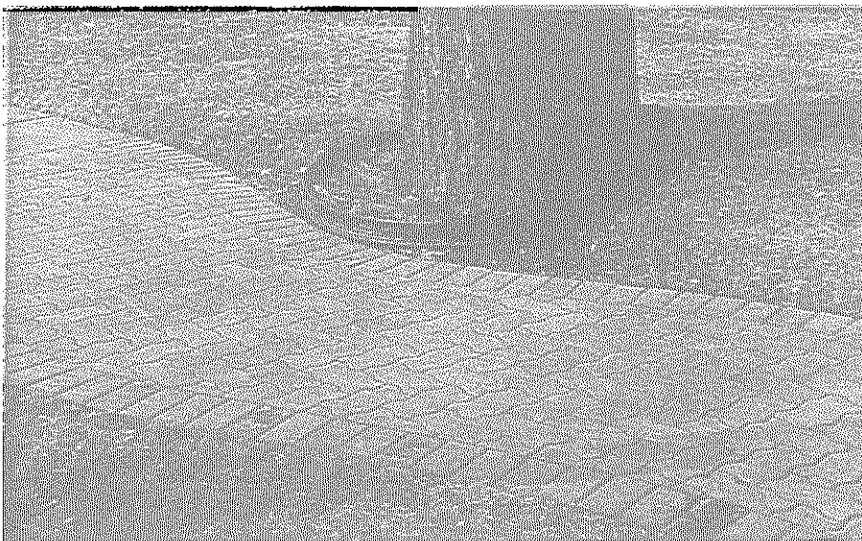
Removing the damaged sidewalk and installing landscape pavers is a very attractive option, but the high unit cost can prohibit this type of repair in most communities (fig. 3). In addition, as roots begin to expand, individual pavers could easily be displaced and would require repair.

Figure 3. Landscape pavers

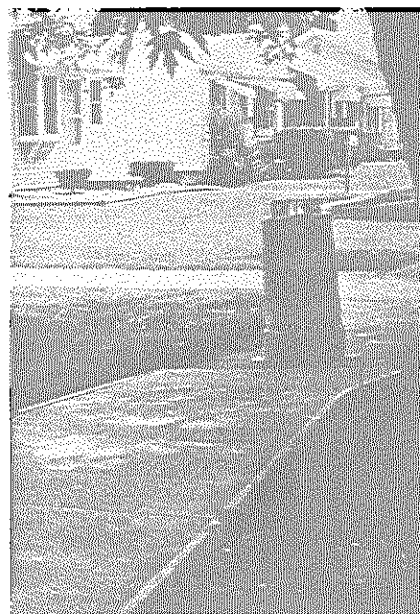
Another option is to remove the damaged sidewalk and install a concrete ramp. The concrete is then poured over the top of uncut roots to create a ramp (fig. 4). Unit cost and material durability are reasonable; however, concrete is a stiff material that can be expected to lift as individual tree roots expand.

Figure 4. Concrete ramp

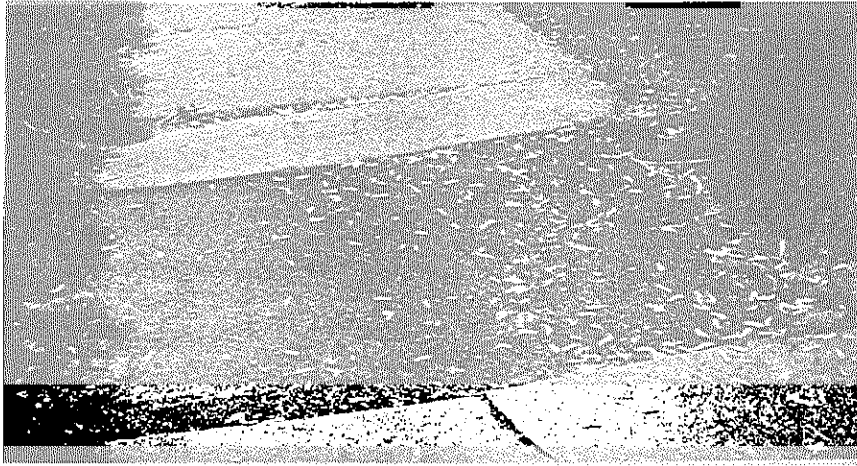
This option involves removing the displaced slabs and installing asphalt over the top of exposed tree roots (fig. 5). Criticisms of this method range from questions of material durability to debris deposited by foot traffic. However, because the unit cost of asphalt is nearly half that of concrete it may be worthwhile to look at this as an option. Since asphalt is both flexible and plastic, displacement from root expansion would likely occur only in the area of the root itself rather than over the entire repaired sidewalk section. Cracks or ridges in the slab could be sealed or repaired by reapplying asphalt to extend the life of the ramp. Issues related to coloration and debris

tracking could be addressed, perhaps through the application of sealers or traffic paint.

Figure 5. Asphalt ramp

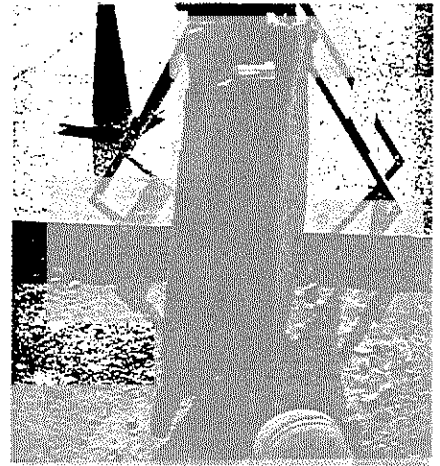
When a wide (2 to 3 foot) excavation bucket is used to remove curbing there is an unusually large amount of disturbance to the tree lawn area. In reality, only a 1- to 1.5- foot wide trench is needed behind the old curb to set forms or run a curb machine, which would reduce the amount of root damage (fig. 6). Specialized teeth or appendages can also be welded to the excavation bucket (fig. 7) and used to pry out individual sections of curb (fig. 8). Minimal root disturbance occurs with this technique, and you have an option of either pouring concrete back into the recently made mold or doing a small

Figure 6. Small bucket

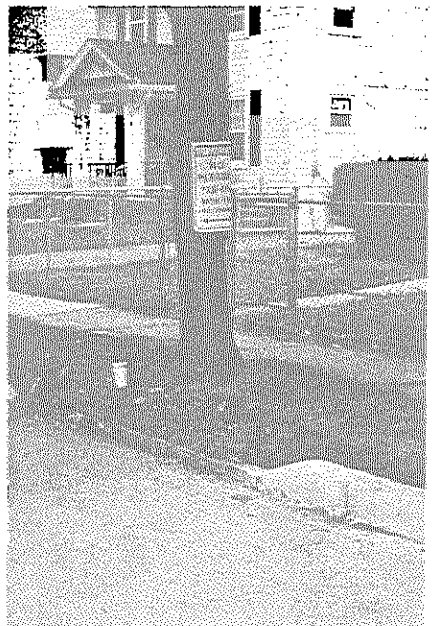
Figure 9. Sloped curb

curbing (fig. 9). Some critics suggest that streets with this type of curbing lack the uniformity of streets where 100 percent of the curbing has been replaced. Also, a concern may be the movement of water over these low curb areas from the tree lawn into the street, creating a possible erosion problem. However, removing all trees from a street in order to accommodate such uniform curbing may negatively impact the continuity and the value of the properties in the neighborhood.

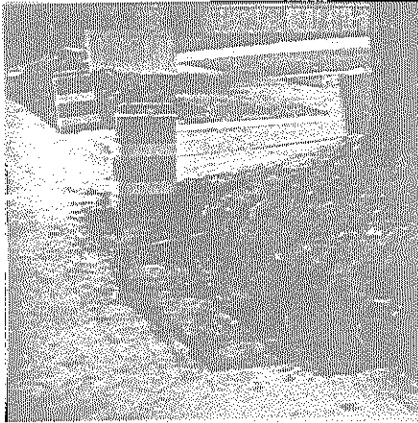
Figure 10. Removed asphalt

damage to a tree. This technique involves cutting a narrow section of pavement adjacent to the curb with a concrete saw and removing the curb and the pavement (fig. 10). A small amount of hand digging may be required for installing the new curb. A section of pavement measuring at least 2 by 10 feet must be removed each time this method is used in order to insure stability of the roadway.
