REF: DOD-1-23 DATE: April 13, 2023

Request - Downtown Overlay District Review of Building

Demolition

Location - 1913 Spielbusch

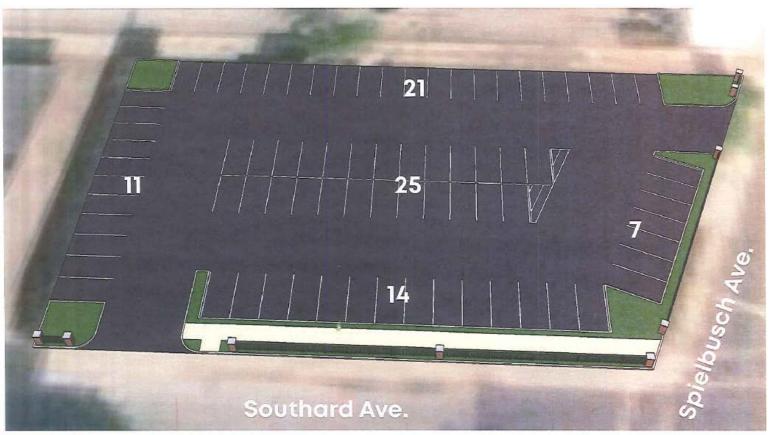
### 1913 Spielbusch Ave Parking Lot Preliminary Layout

Yields 78 parking spaces
Decorative fencing included

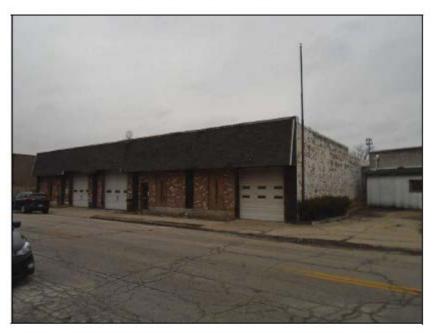
SUBJECT PHOTOS Exterior View of the Subject

The building is composed of two (2) connected structures. The first structure is a former fueling station nearest to the corner of Southard and Spielbusch. It is single-story and approximately  $\pm 2,100$  square feet. The three facades visible from the road are predominantly brick. An accent banding is provided above the window and doorline. None of the entrances appear to utilize architectural elements such as transom or sidelight windows to emphasize a "primary" entrance to the building. A wooden-clad addition can be seen on the southern elevation. Historic documentation indicates the addition covers the former location of several garage bay doors. Existing garage bay doors can be seen on the northern elevation of the building. On the eastern elevation of the building a glass-block window is utilized, distinct from the wood-framed 4-panel windows used elsewhere.

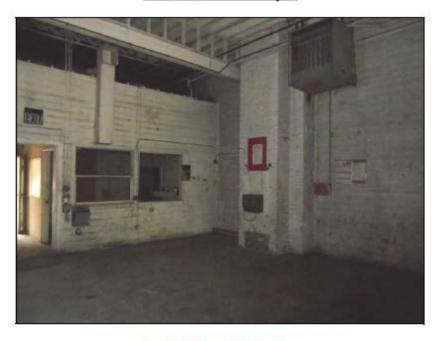
### INTERIOR VIEWS Interior View of the Subject

The second structure composing the subject building is approximately  $\pm 13,190$  square feet. It is a one-story industrial service garage constructed in 1925. It is adjoined to the first structure via a wood-clad addition. The service garage has multiple bays and is constructed steel frame and a mixture of brick and concrete masonry units.
