# STATE OF FACILITIES City of Toledo Fire and Rescue Department March 2023

Woolpert was engaged by the Toledo Fire and Rescue Department (TFRD) to conduct a facility condition assessment (FCA), which is an evaluation of the general health of physical facilities by identifying and prioritizing deficiencies that require correction for long-term use. Evaluations focused on in-kind replacements; upgrades or enhancements were not considered part of the assessment. An FCA is a snapshot of the asset conditions as observed on the days of the site visit and certain building deficiencies may not be apparent.

Date of assessment: November 2022 Facilities assessed: 24 Area assessed: 281,000 square feet

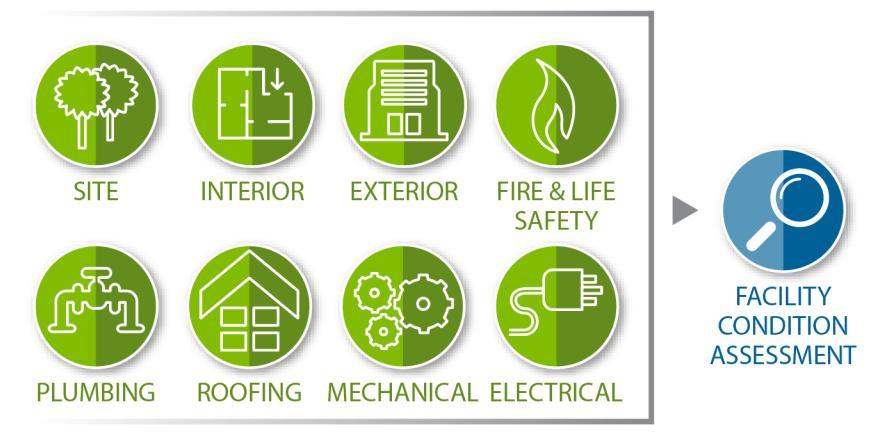
Figure 1: Facility Condition Assessment Building Systems

Figure 1 illustrates the components of each facility that was included in each building assessment. Additionally, the assessment incorporated input provided by facility end-users, where applicable. At the conclusion of the building assessment, findings were compiled to develop the current repair costs and anticipated future life cycle needs for each facility.

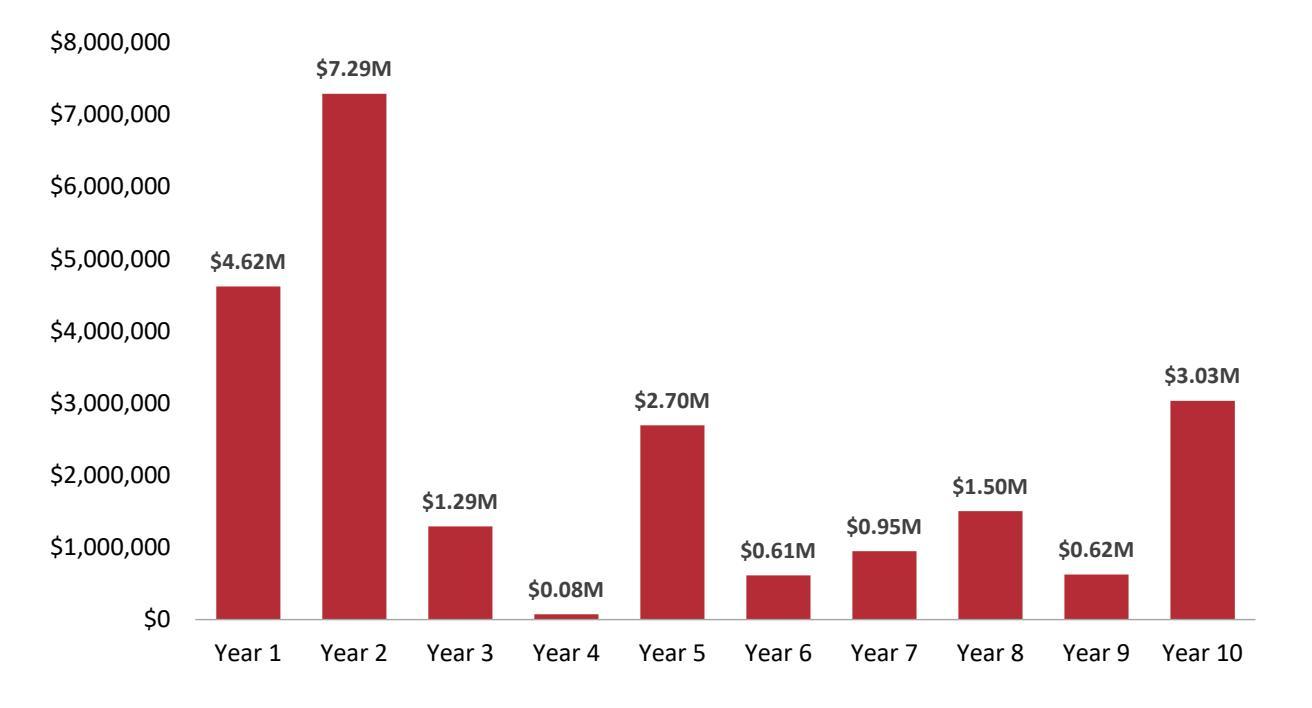
Figure 2: 10-Year Life Cycle Renewal Forecast for Major Building Systems

Figure 2 provides the 10-year life cycle renewal forecast for major building systems. The 10-year capital renewal cost is \$22,703,850. Over 50 percent of the ten-year need is expected in the next two years. One million of the need in year two is associated with replacing the Burn Building. It should be noted that these values and timings are estimated for capital planning purposes. The TFRD should anticipate significant investment in their facilities in the near term. See Appendix B for summary information.

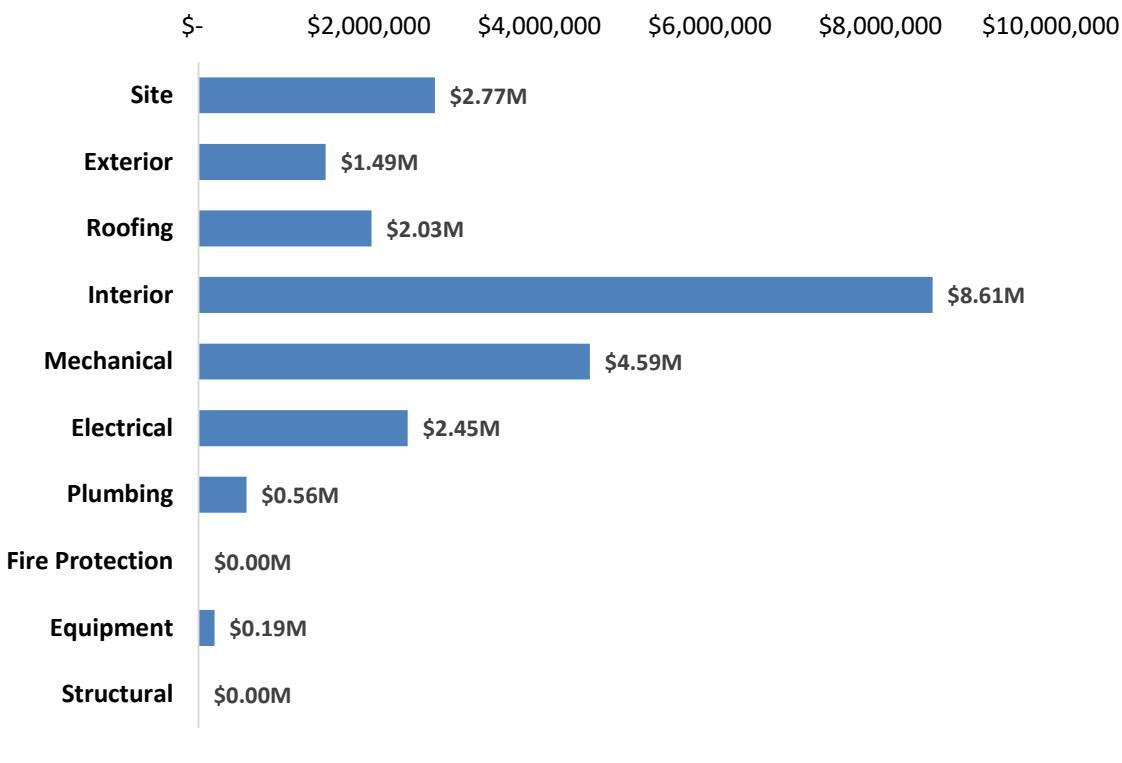
Figure 3: 10-Year Need by Building System

Figure 3 illustrates the 10-year forecast by major building systems. Approximately 38 percent of the future need is related to the interior building finishes with most of the interior finishes needing replacement in the next five years. It should be noted that just over one million dollars of this need is related to the Burn Building replacement. Mechanical systems make up approximately 20 percent of the need, with most of these replacements expected in years 6-10.

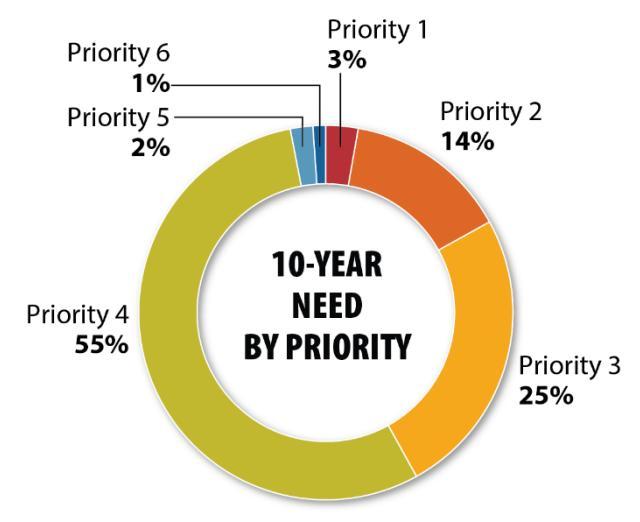
Figure 4: 10-Year Need by Priority

Figure 4 shows the 10-year need by priority for the TFRD facilities. Over 55 percent of the need is considered Priority 4, indicating these repairs are needed but not required for the facility to function. Priority 1 deficiencies noted were related to fire alarm and sprinkler systems in need of replacement with most of the need noted at Station 6 and Headquarters. Roof replacements comprise approximately half of the Priority 2 replacement items and were identified for replacement in the next two year.

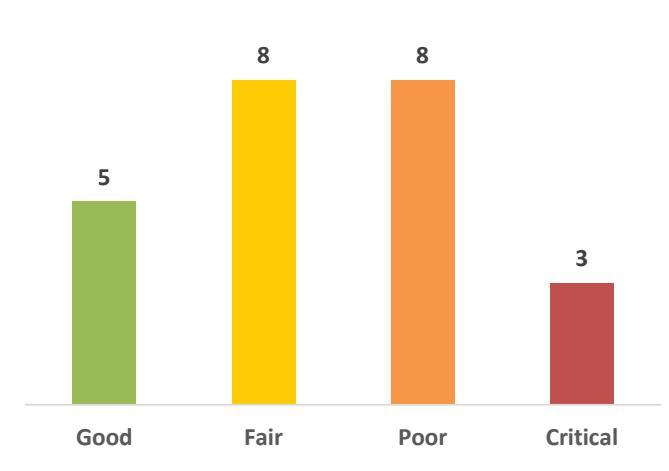
Figure 7: Building Count by FCI Condition Rating

Approximately half of TFRD facilities are considered in fair condition. Airport Training, Building Maintenance and the Burn Building are considered in critical condition with a 3-Year FCI of 32 percent, 73 percent, and 100 percent, respectively. Fire Stations noted in poor condition include Stations 4, 7, 9, 11, 13, 14, and 16. Imlay Vehicle Maintenance is also considered in poor condition with an FCI of 25 percent. Individual building FCI's can be found in Appendix A.
